**ILLINOIS ENVIRONMENTAL PROTECTION AGENCY
MEMORANDUM**

DATE: 13 October 2010

SUBJECT: LPC #1198010003 – Madison County
Hartford/Chemetco
FOS File

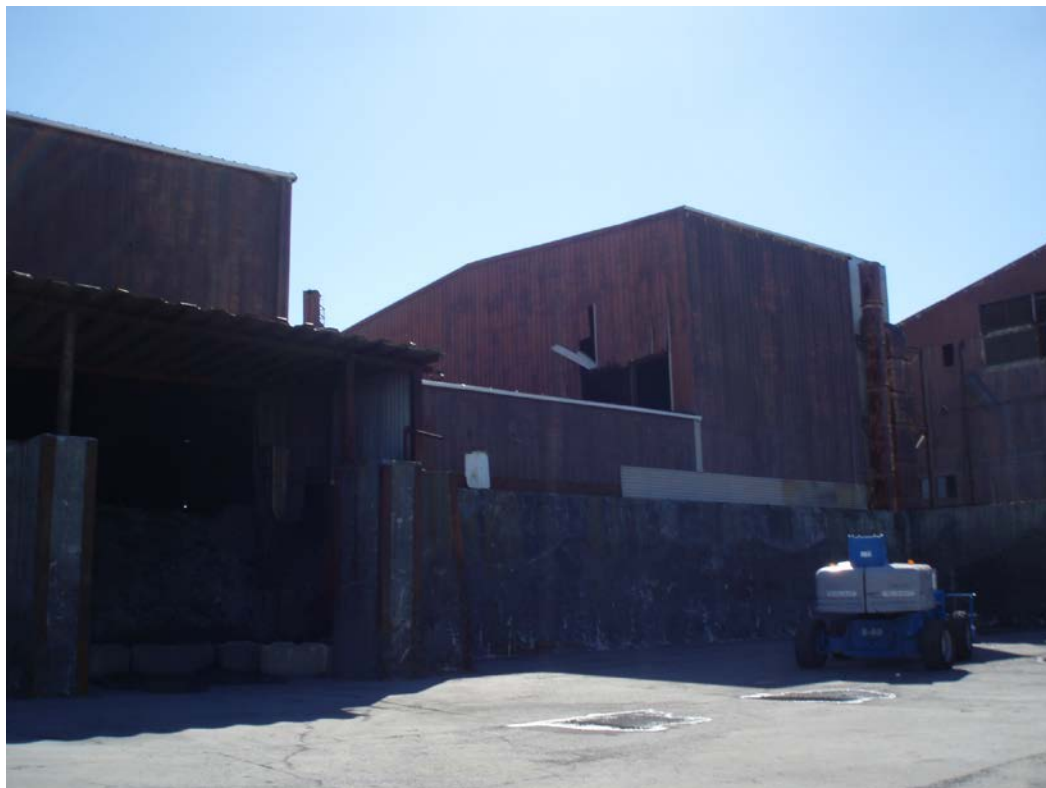
The gutters installed on the DIS Building are shown in the attached photos #001 and #002. The downspouts will be placed on the building in the near future. The attached photo #002 shows the floor of the dome building. This area will be used as a scrap steel wet decontamination area.

Date: 30 September 2010
Time: 11:04 am
Direction: SE
Photo by: M. Cozadd
Exposure #: 001
Comments: Gutter
installed on DIS Building.

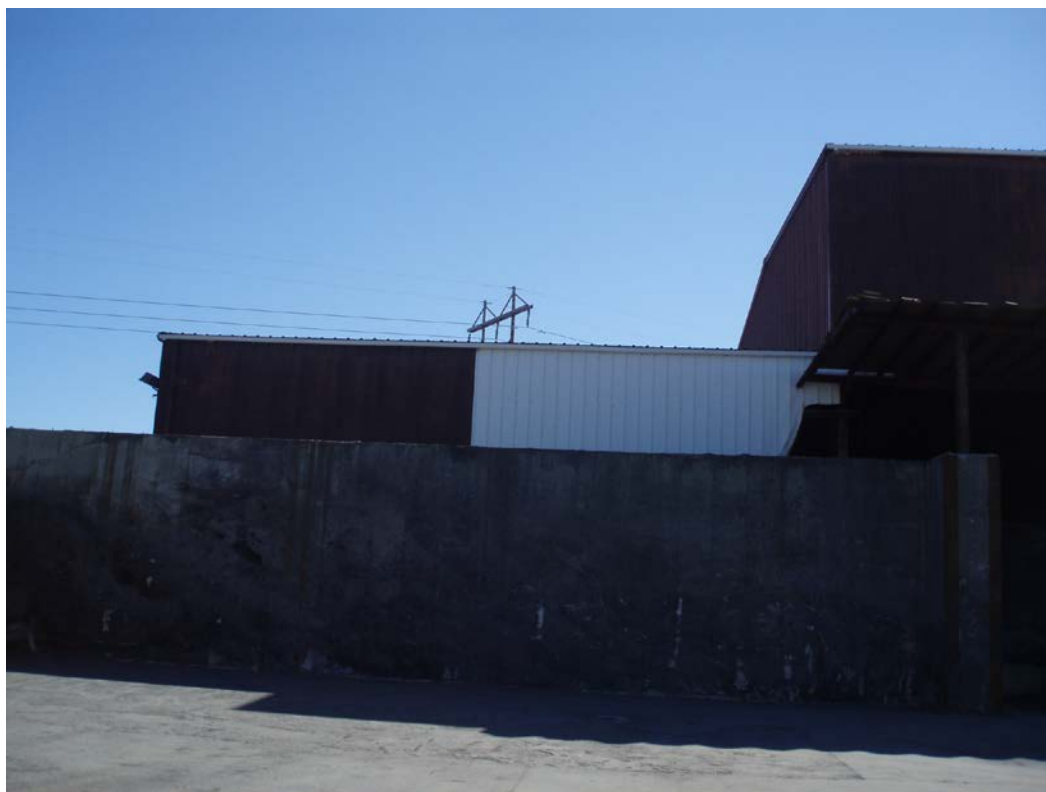
Date: 30 September 2010
Time: 11:04 am
Direction: E
Photo by: M. Cozadd
Exposure #: 002
Comments: Gutter
installed on DIS Building.

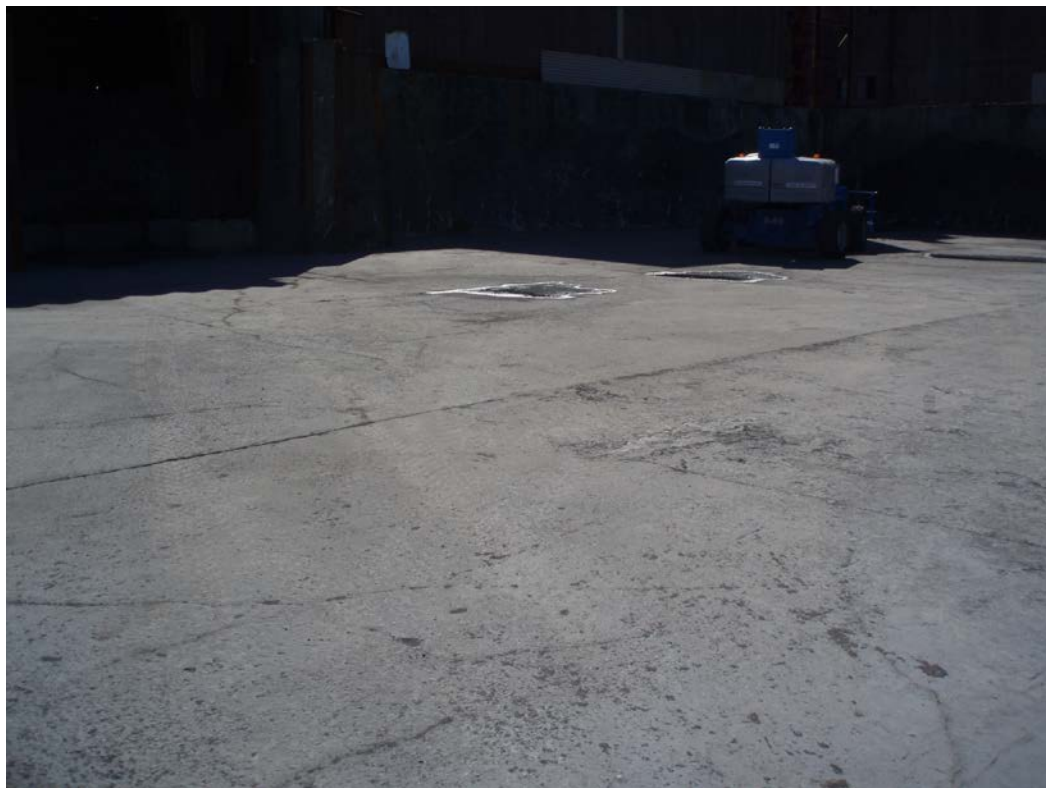
Date: 30 September 2010
Time: 11:04 am
Direction: SE
Photo by: M. Cozadd
Exposure #: 003
Comments: Floor of Dome Building.

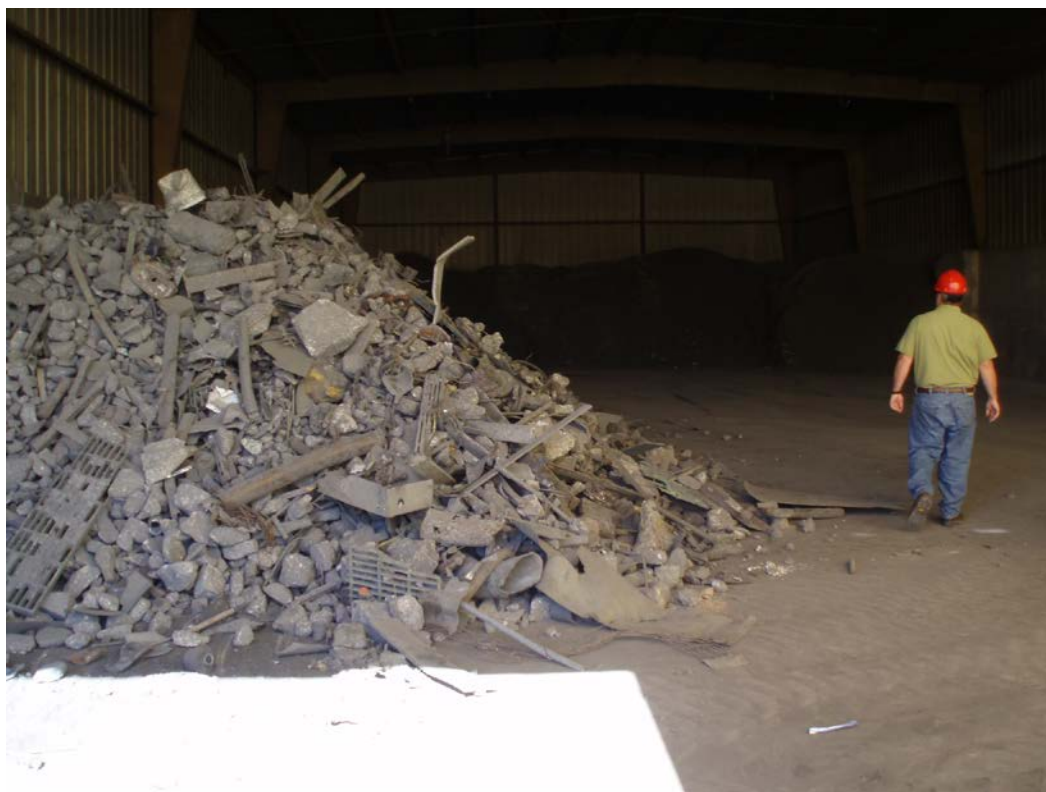
The screening operation was completed prior to the September 30, 2010 site visit. The screening equipment has been removed from the site. The screening generated a waste pile of broken concrete, damaged dimensional lumber, and other miscellaneous wastes (see attached photos #004 through #006). The pile will be profiled for proper disposal. One 55-gallon drum was observed just outside the Fines Building as illustrated in the attached photo #008. The drum was closed and labeled. The attached photo #009 is a close-up of the hazardous waste label (D006 & D008) with a September 28, 2010 accumulation start date.

Date: 30 September 2010
Time: 11:07 am
Direction: NW
Photo by: M. Cozadd
Exposure #: 004
Comments: Segregated broken concrete, damaged dimensional lumber, and other miscellaneous wastes from screening operations in fines building.

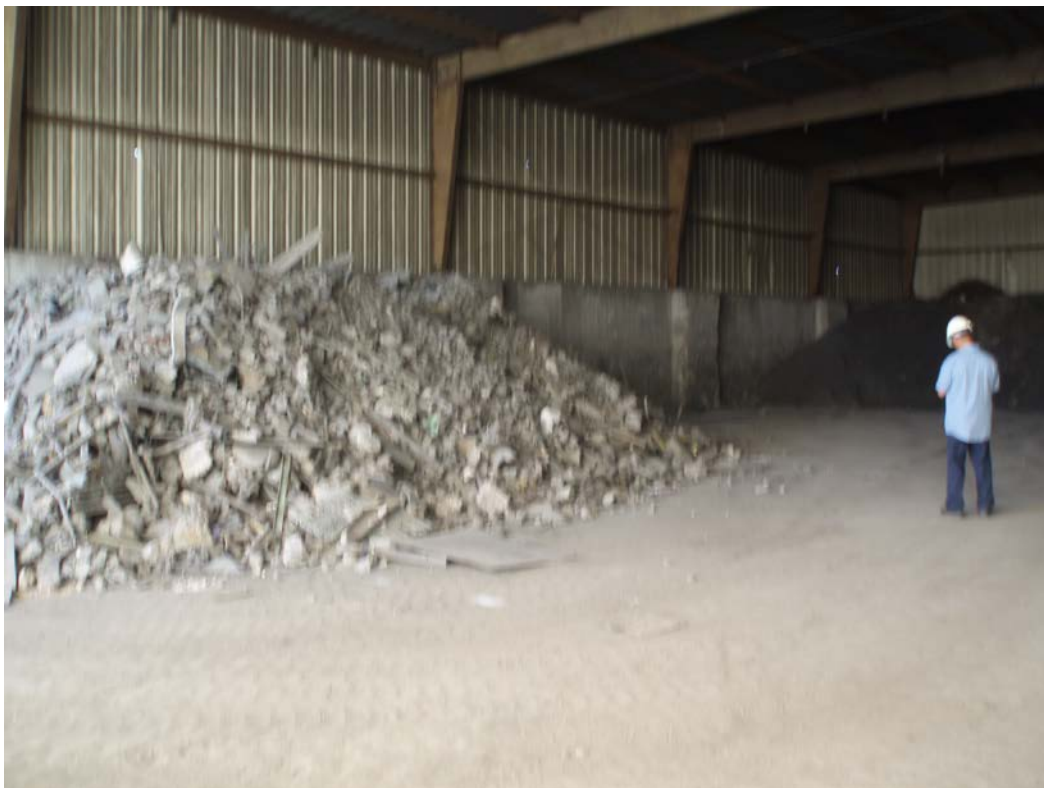
Date: 30 September 2010
Time: 11:07 am
Direction: W
Photo by: M. Cozadd
Exposure #: 005
Comments: Segregated broken concrete, damaged dimensional lumber, and other miscellaneous wastes from screening operations in fines building.

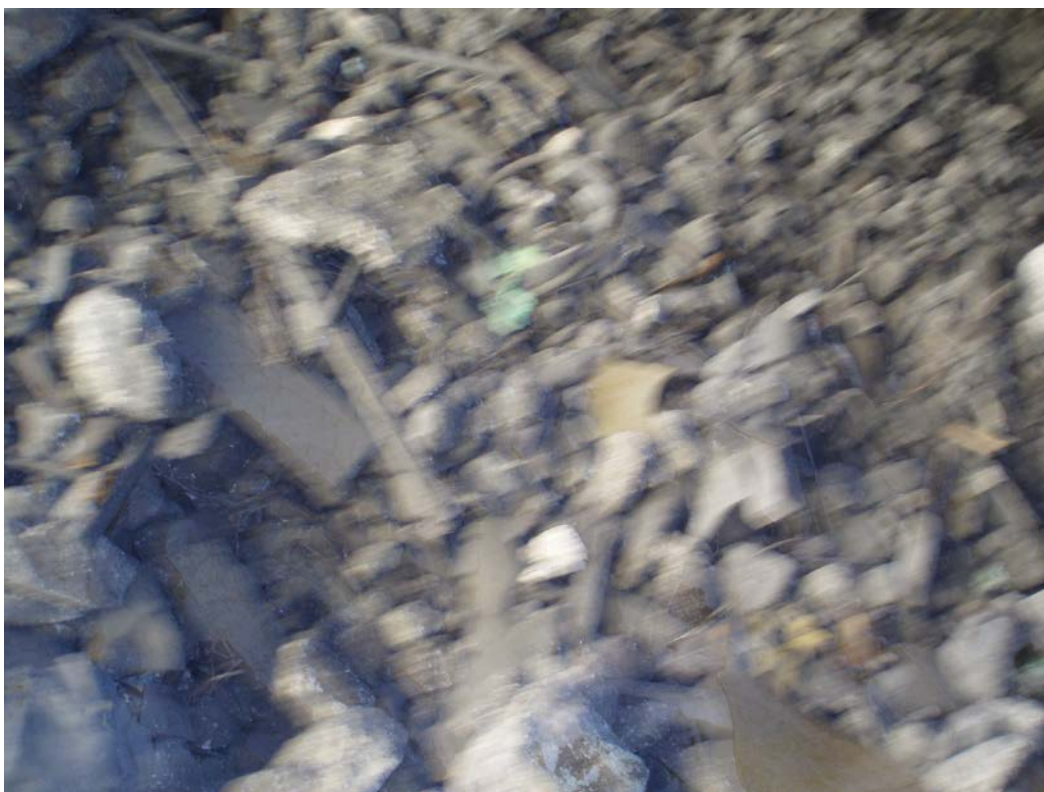
Date: 30 September 2010
Time: 11:08 am
Direction: W
Photo by: M. Cozadd
Exposure #: 006
Comments: Close-up of segregated broken concrete, damaged dimensional lumber, and other miscellaneous wastes from screening operations in fines building.

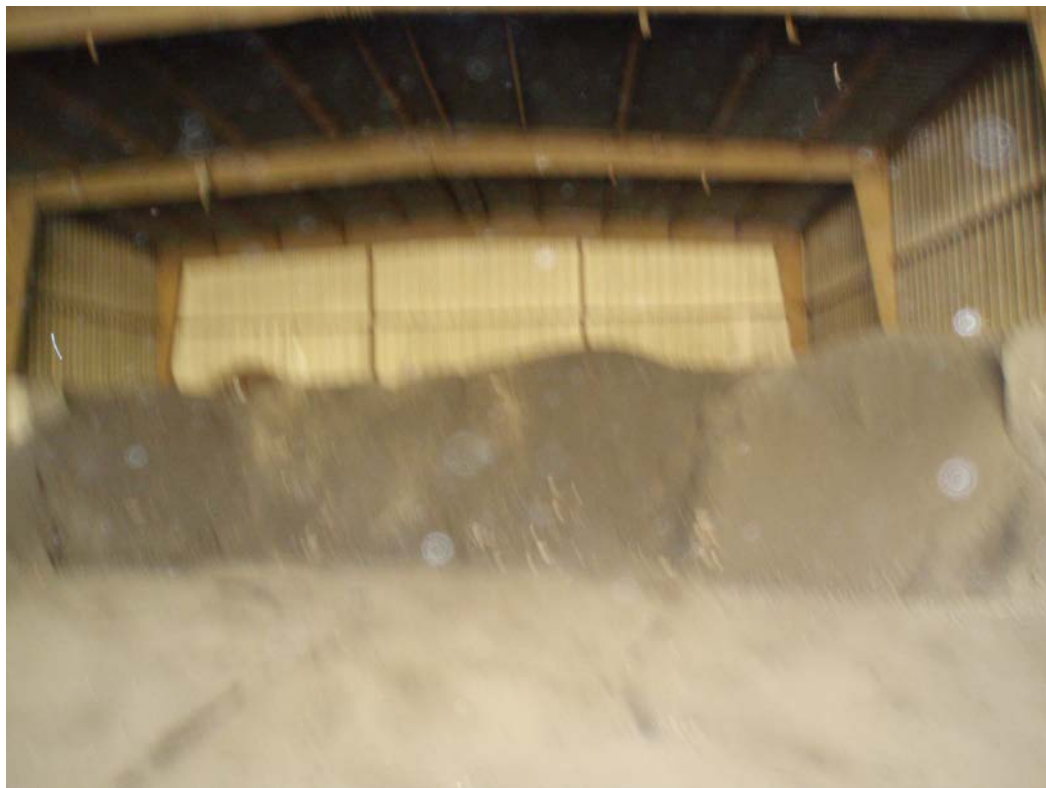
Date: 30 September 2010
Time: 11:08 am
Direction: NW
Photo by: M. Cozadd
Exposure #: 007
Comments: Screened materials adjacent to northeastern wall of Fines Building.

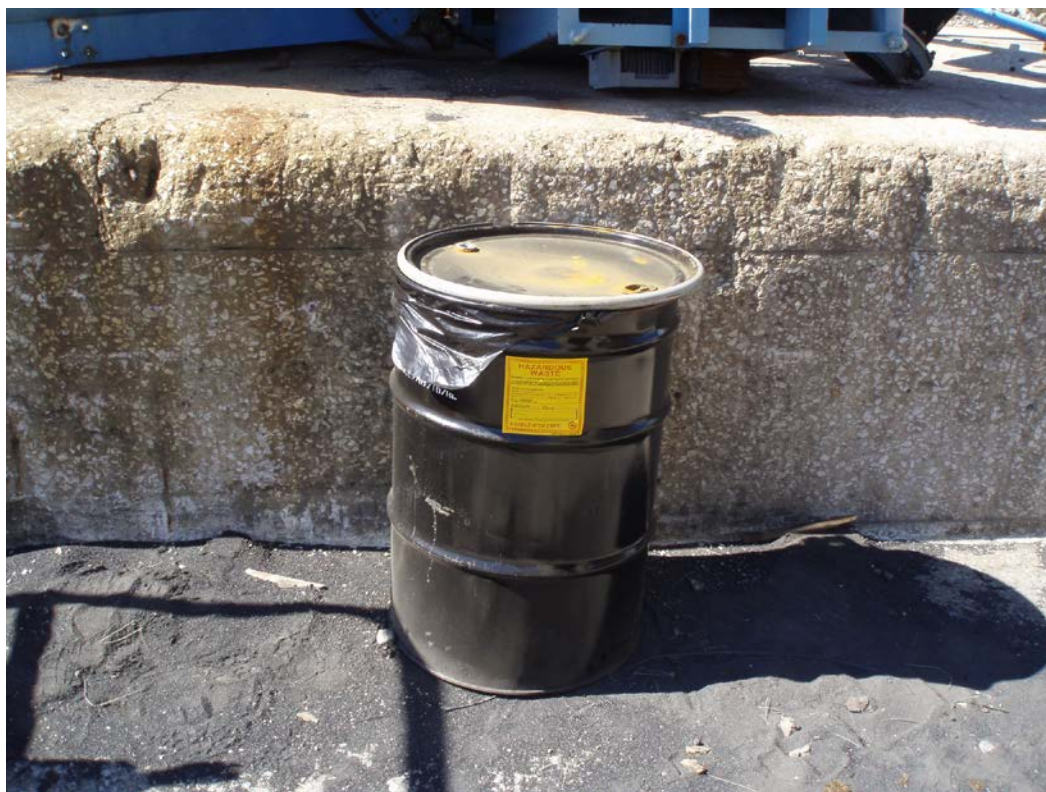
Date: 30 September 2010
Time: 11:10 am
Direction: SW
Photo by: M. Cozadd
Exposure #: 008
Comments: Hazardous waste drum outside of Fines Building.

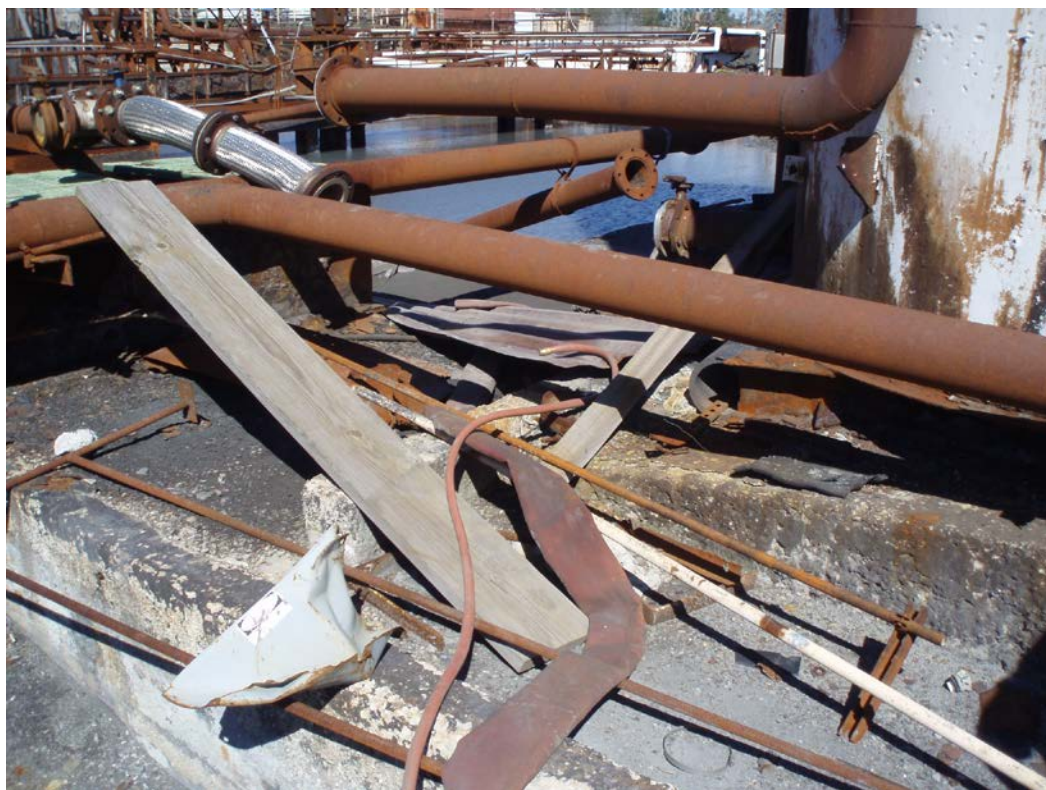
The caustic tank near the AAF decontamination area is shown in the attached photo #010. This caustic tank will be cleaned and removed from the site in the near future. The attached photos #011 through #016 shows a hose leading from a sump to a polishing pit in the AAF area. There was a concern that decontamination rinse liquids were being pumped into the polishing pit. Mr. Michael Murray with AIS later explained that the hose was only for use to pump storm water and all decontamination rinse liquids will be collected in a temporary water storage tank.

Date: 30 September 2010
Time: 11:22 am
Direction: NW
Photo by: M. Cozadd
Exposure #: 011
Comments: Hose near
AAF Decontamination
Area.

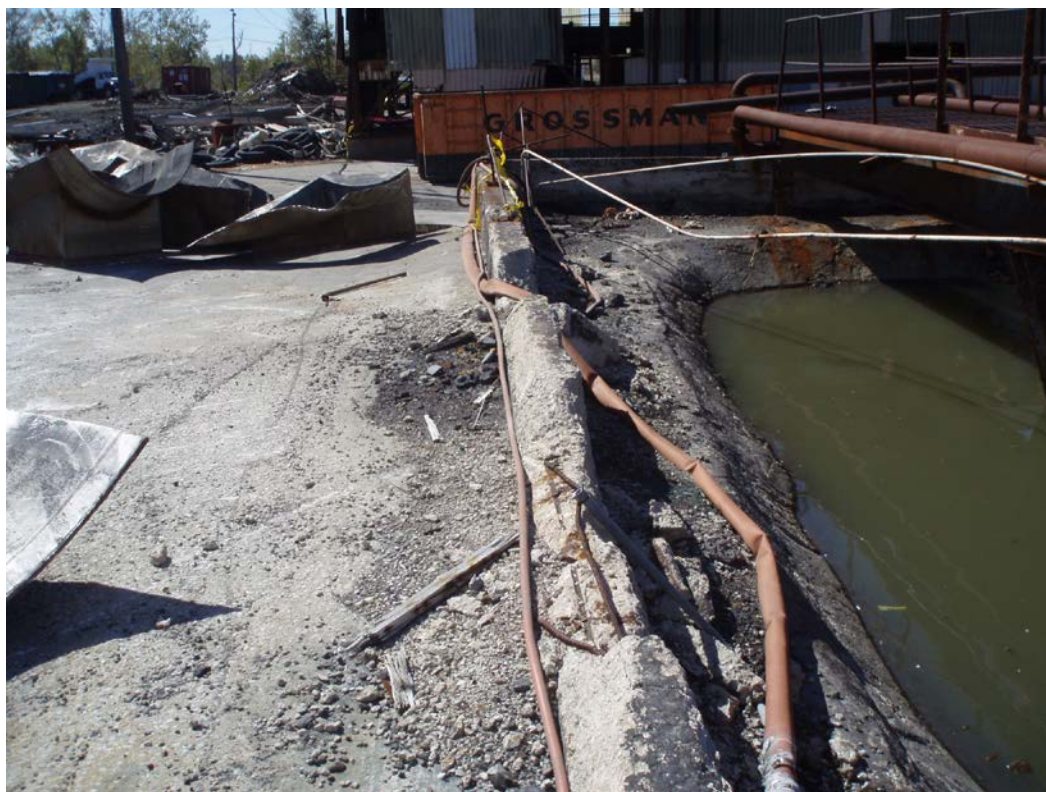
Date: 30 September 2010
Time: 11:22 am
Direction: S
Photo by: M. Cozadd
Exposure #: 012
Comments: Hose near
AAF Decontamination
Area.

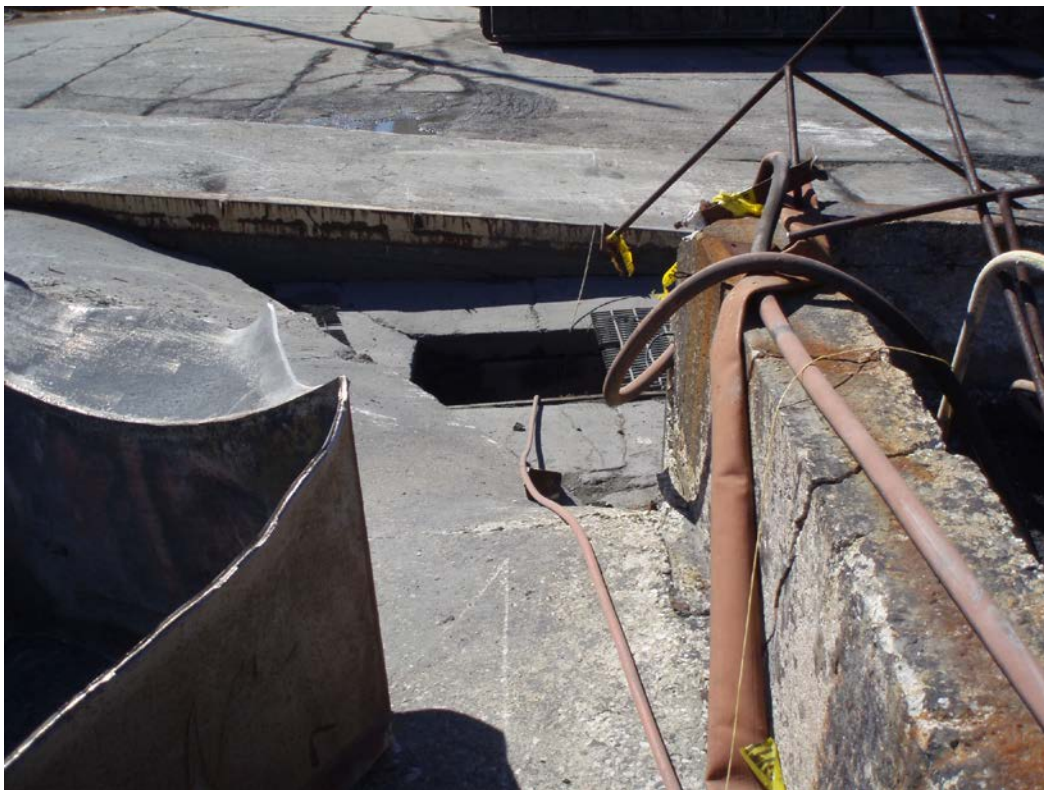
Date: 30 September 2010
Time: 11:22 am
Direction: S
Photo by: M. Cozadd
Exposure #: 013
Comments: Hose leading from sump near AAF Decontamination Area.

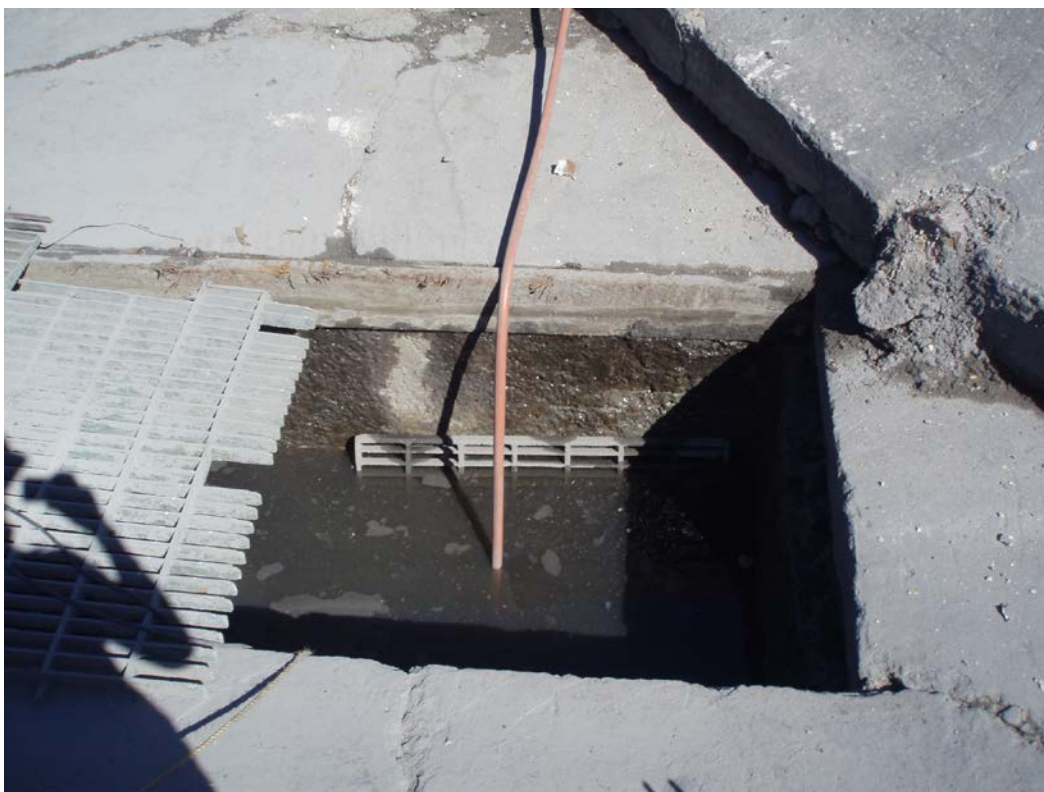
Date: 30 September 2010
Time: 11:22 am
Direction: N
Photo by: M. Cozadd
Exposure #: 014
Comments: Hose leading from sump near AAF Decontamination Area.

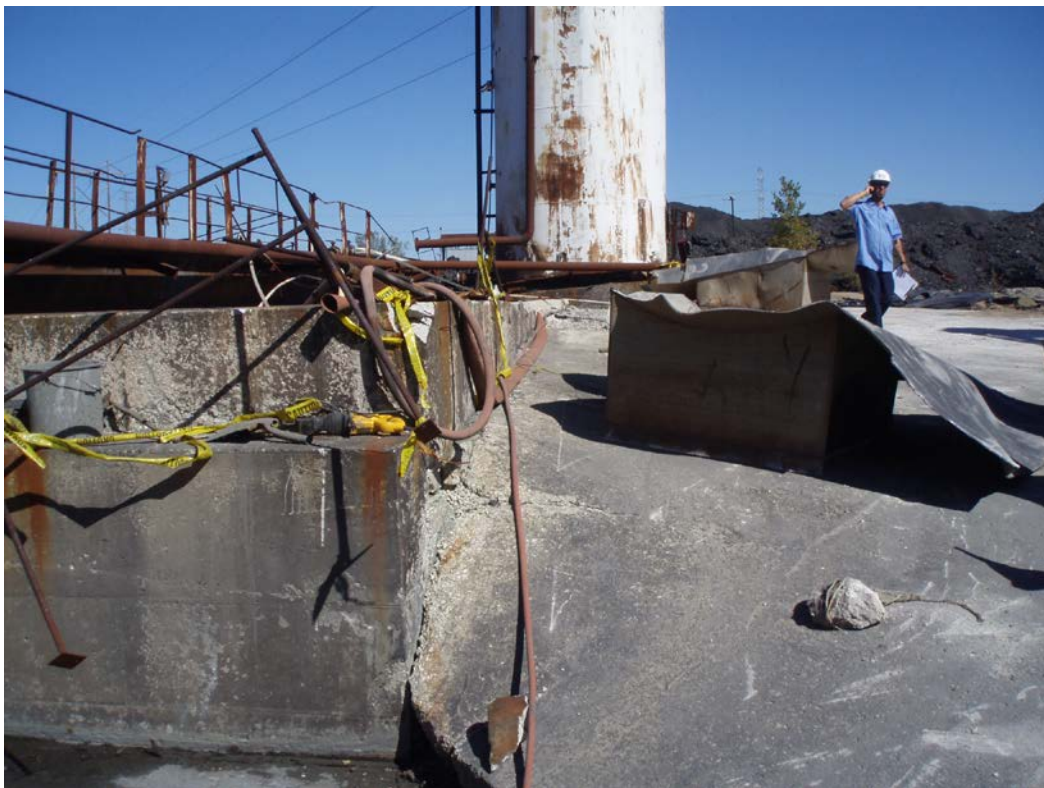
Date: 30 September 2010
Time: 11:22 am
Direction: N
Photo by: M. Cozadd
Exposure #: 015
Comments: Hose near
AAF Decontamination
Area.

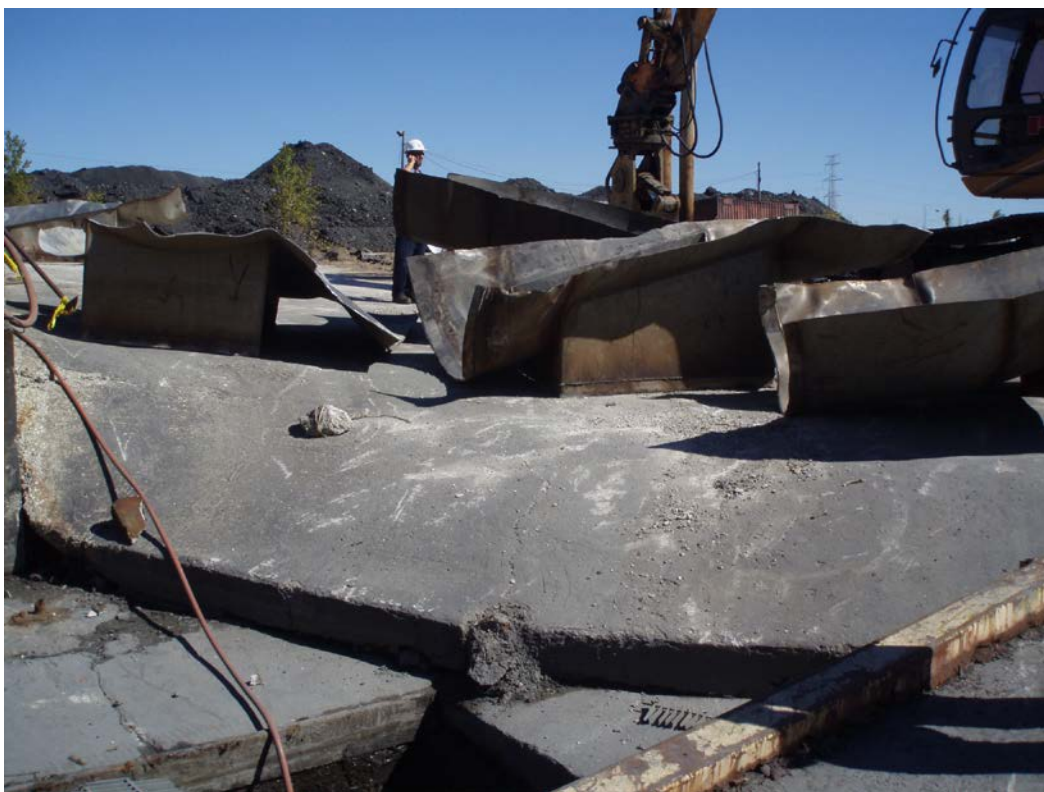
Date: 30 September 2010
Time: 11:23 am
Direction: NE
Photo by: M. Cozadd
Exposure #: 016
Comments: Hose near
AAF Decontamination
Area.

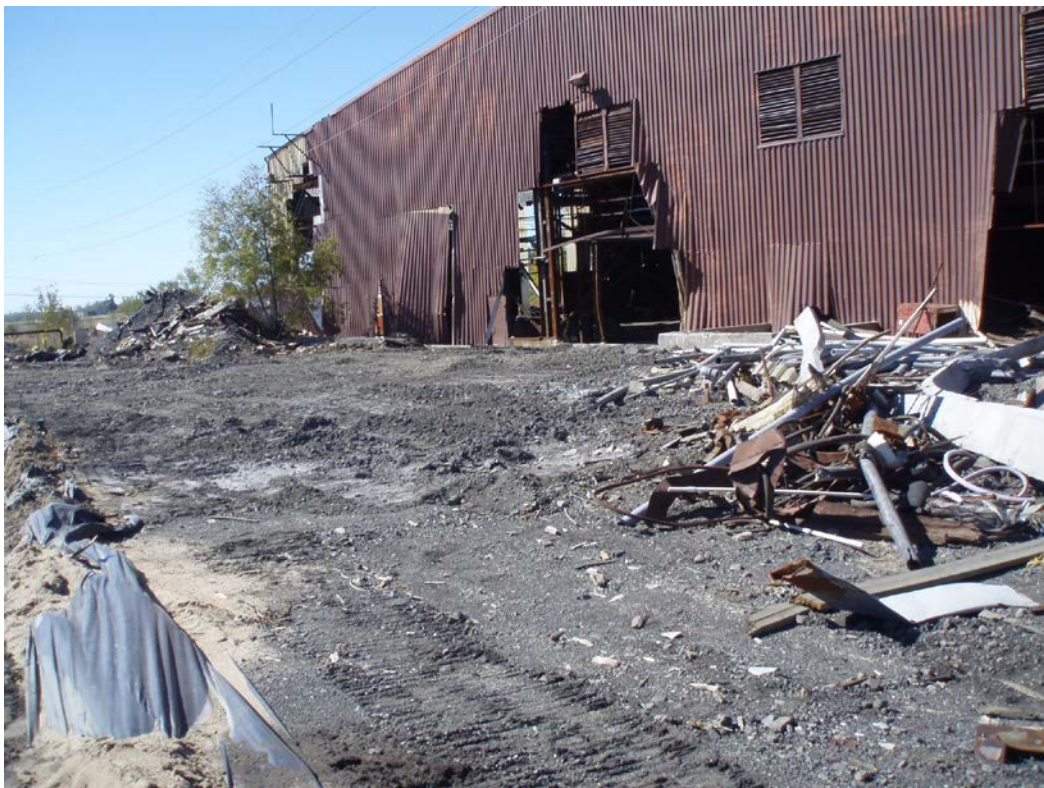
The attached photos #017 and #018 show the outdoor area directly adjacent to the east wall of the Tank House. Additional cleanup has occurred in the area since the previous Illinois EPA site visit on September 24, 2010. The attached photo #018 also shows four of the six full RCRA bins staged for disposal.

Date: 30 September 2010
Time: 11:26 am
Direction: SW
Photo by: M. Cozadd
Exposure #: 017
Comments: Area adjacent to east wall of Tank House.

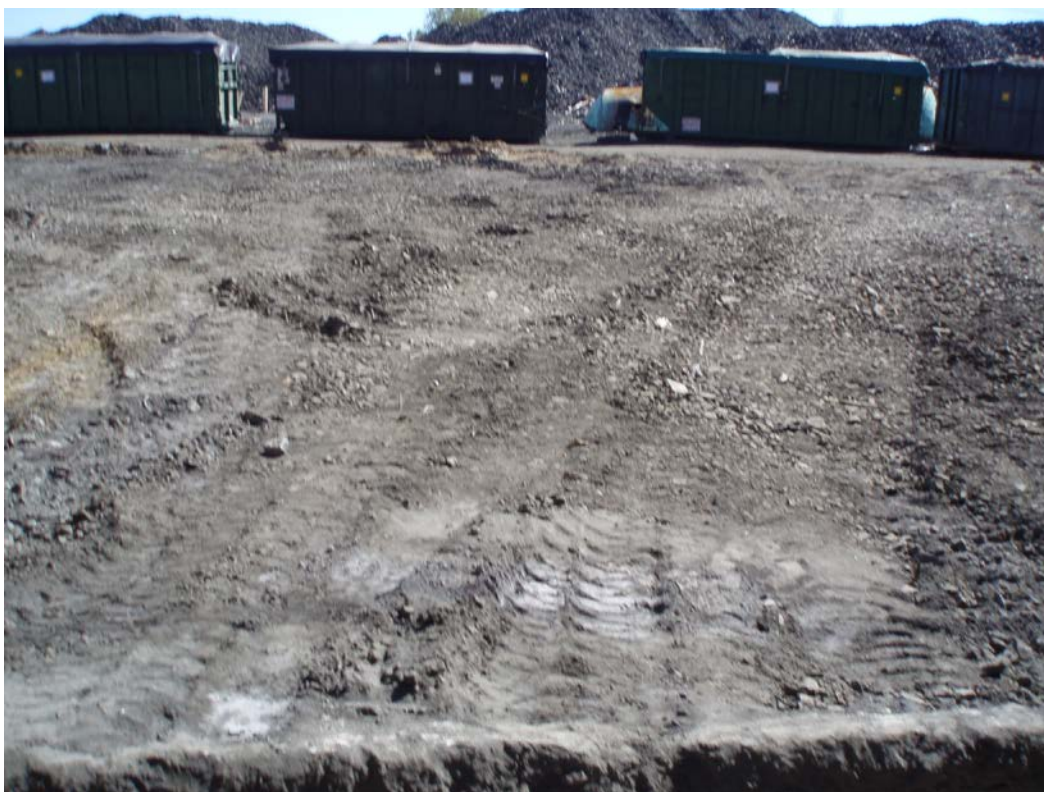
Date: 30 September 2010
Time: 11:28 am
Direction: E
Photo by: M. Cozadd
Exposure #: 018
Comments: RCRA bins awaiting profile east of Tank House.

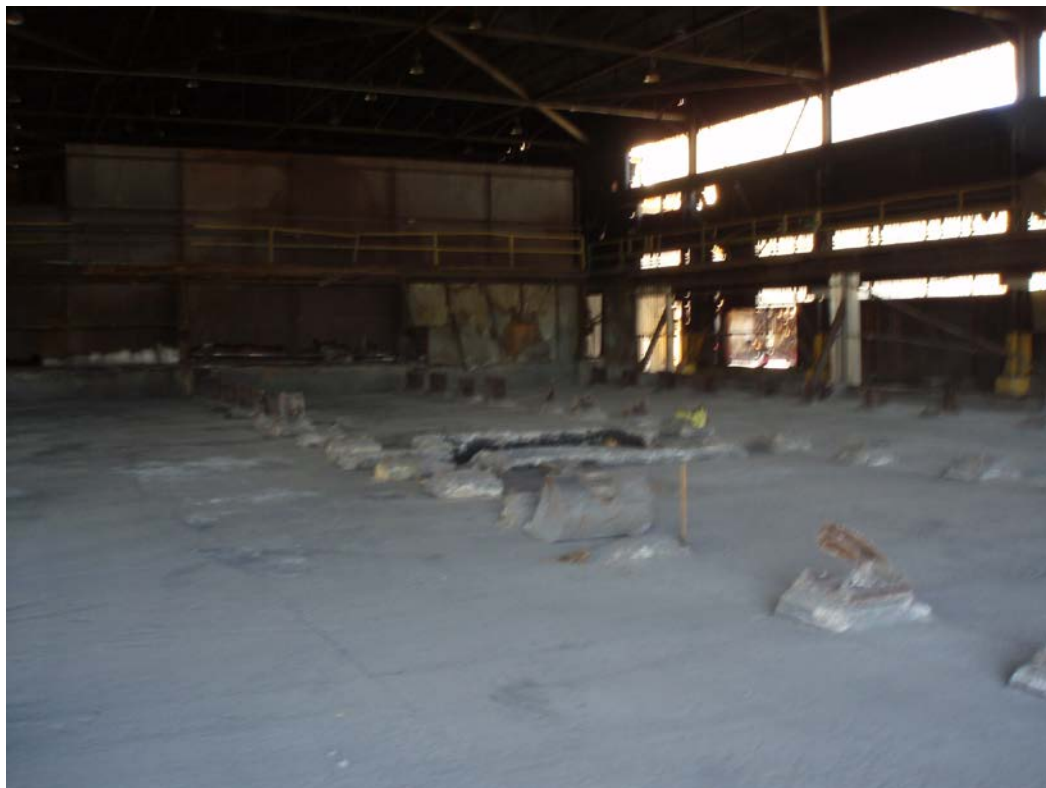
Date: 30 September 2010
Time: 11:28 am
Direction: NW
Photo by: M. Cozadd
Exposure #: 019
Comments: Interior of Tank House.

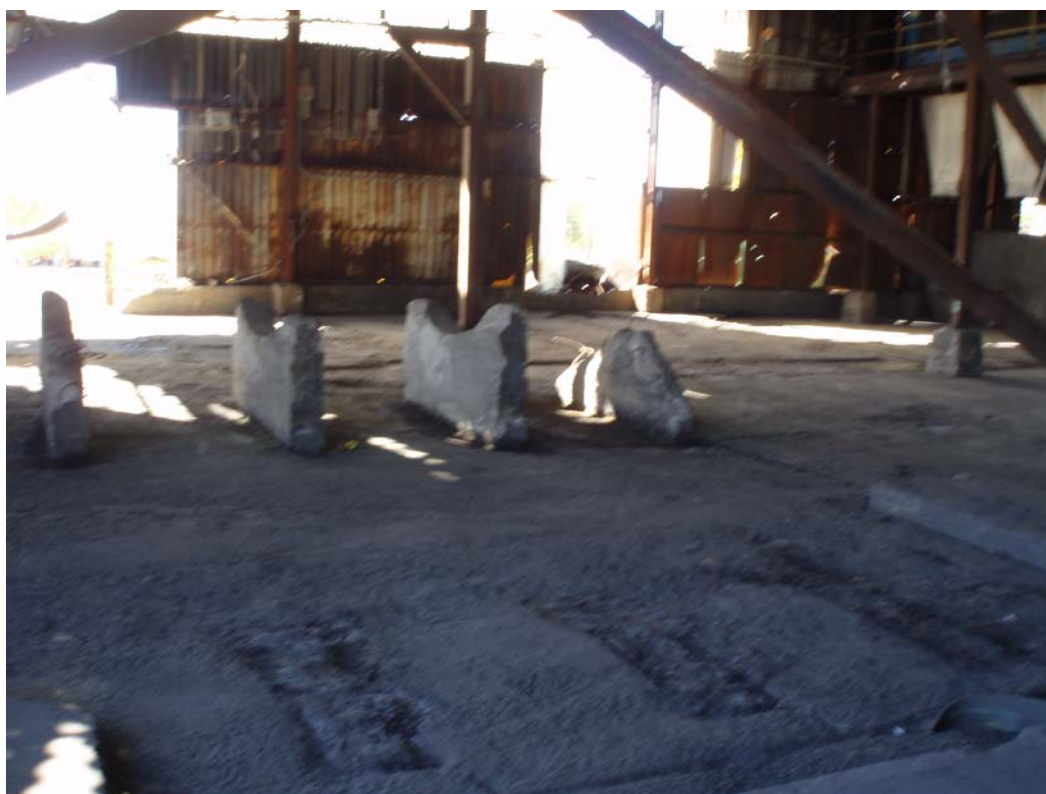
Date: 30 September 2010
Time: 11:28 am
Direction: SW
Photo by: M. Cozadd
Exposure #: 020
Comments: Interior of Tank House.

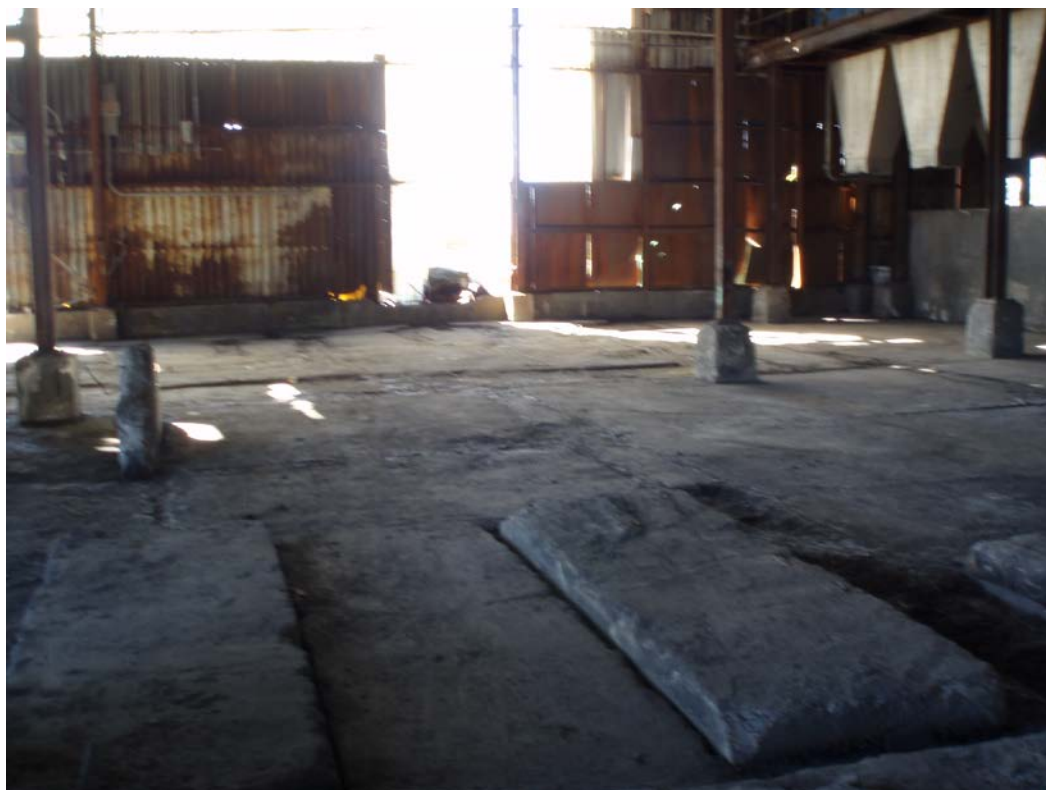
Date: 30 September 2010
Time: 11:28 am
Direction: SW
Photo by: M. Cozadd
Exposure #: 021
Comments: Interior of Tank House.

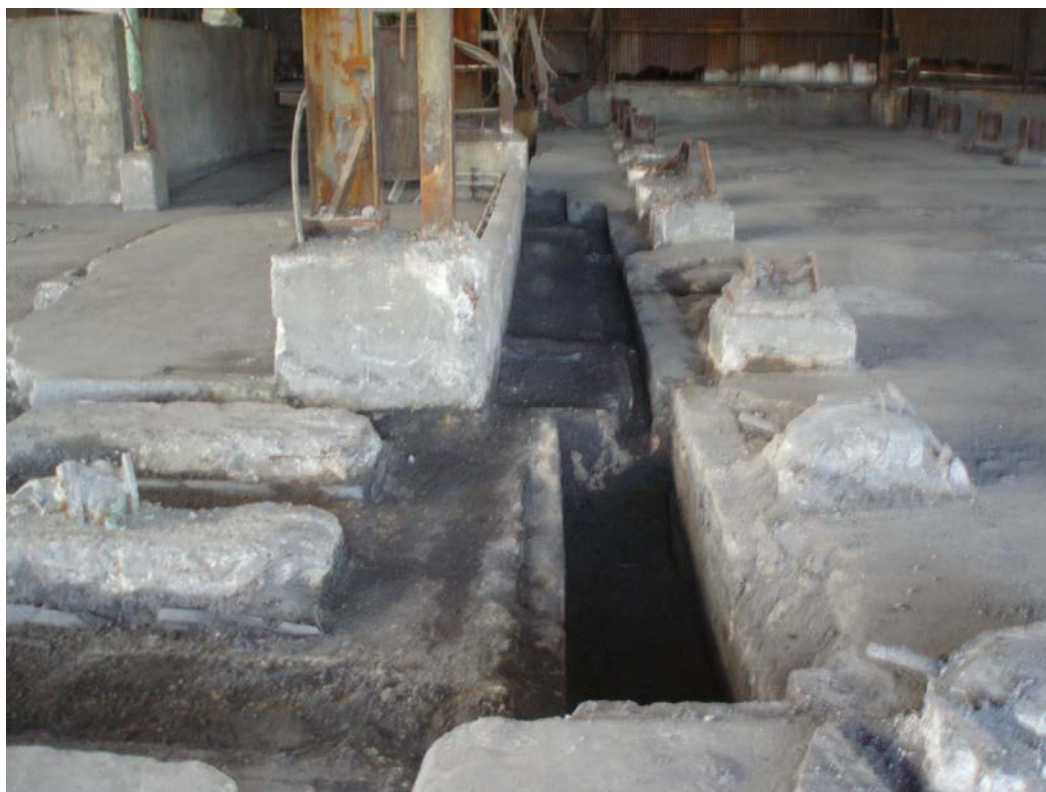
The interior of the Tank House is illustrated in the attached photos #019 through #026. The trench had been cleaned out since the September 24, 2010 site visit. The sump inside the Tank House is shown in the attached photos #023 and #024. In addition, the attached photos #025 and #026 show the refractory brick staged on pallets and in drums.

Date: 30 September 2010
Time: 11:28 am
Direction: W
Photo by: M. Cozadd
Exposure #: 022
Comments: Trench cleaned out inside Tank House since previous Illinois EPA site visit on September 24, 2010.

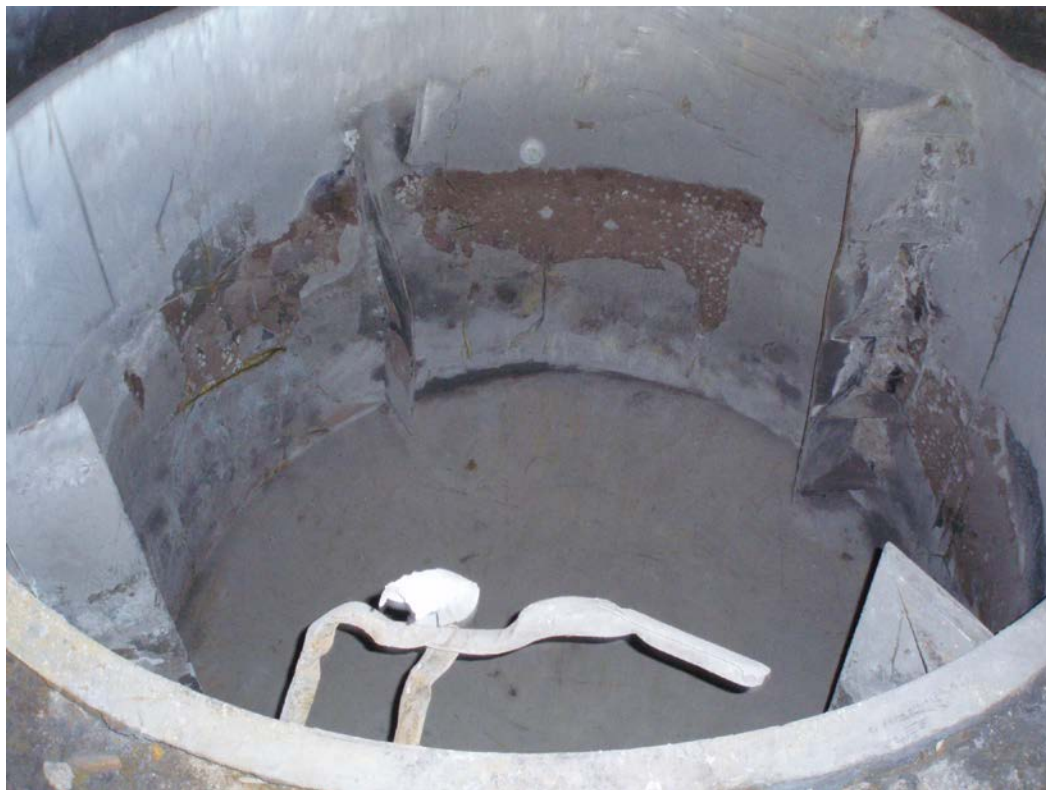
Date: 30 September 2010
Time: 11:30 am
Direction: N
Photo by: M. Cozadd
Exposure #: 023
Comments: Sump
inside Tank House.

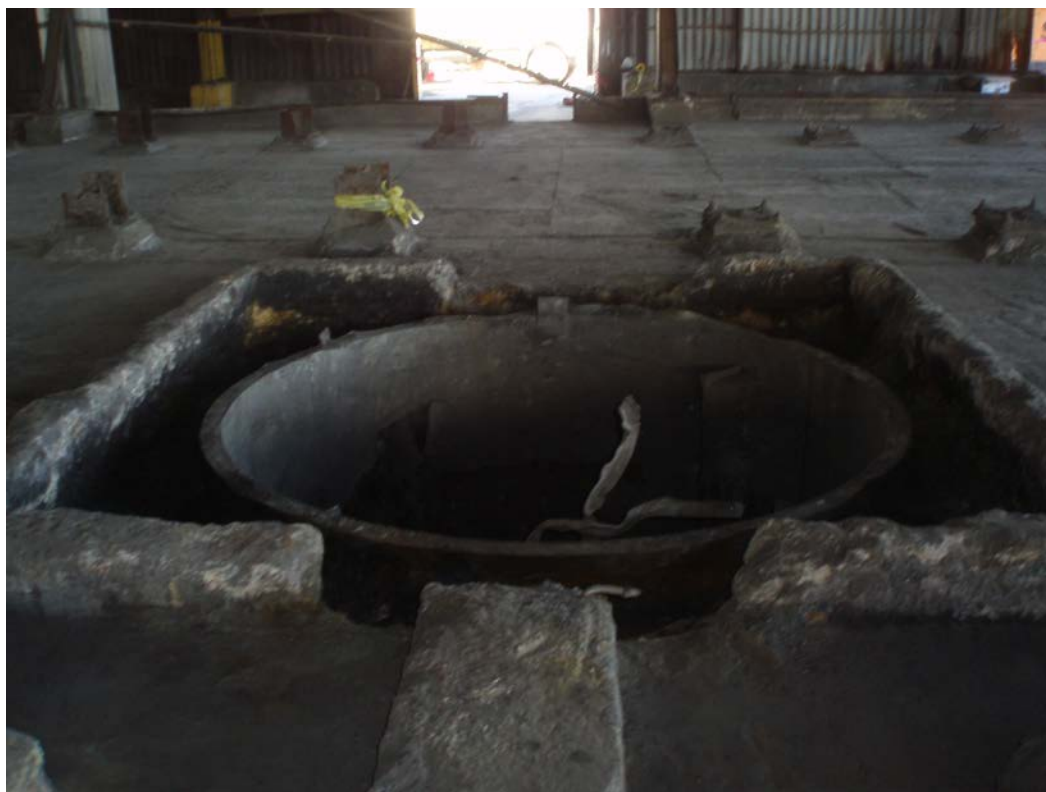
Date: 30 September 2010
Time: 11:30 am
Direction: N
Photo by: M. Cozadd
Exposure #: 024
Comments: Sump
inside Tank House.

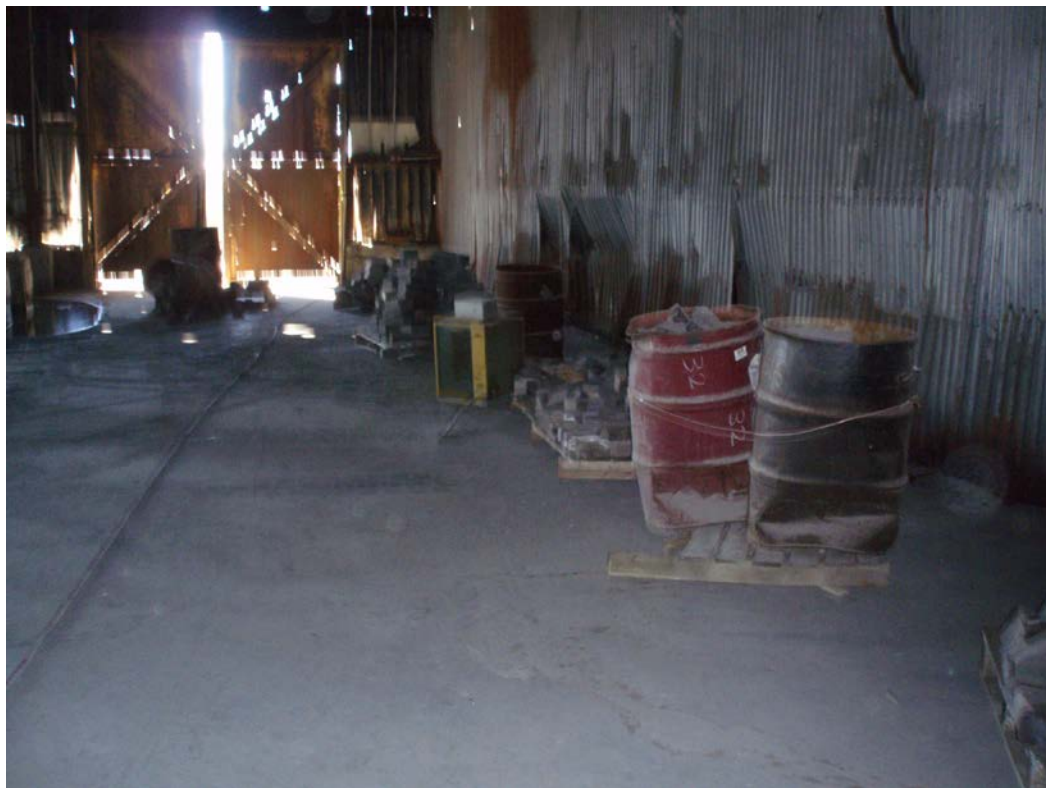
Date: 30 September 2010
Time: 11:31 am
Direction: SW
Photo by: M. Cozadd
Exposure #: 025
Comments: Refractory brick staged on pallets and in drums inside Tank House.

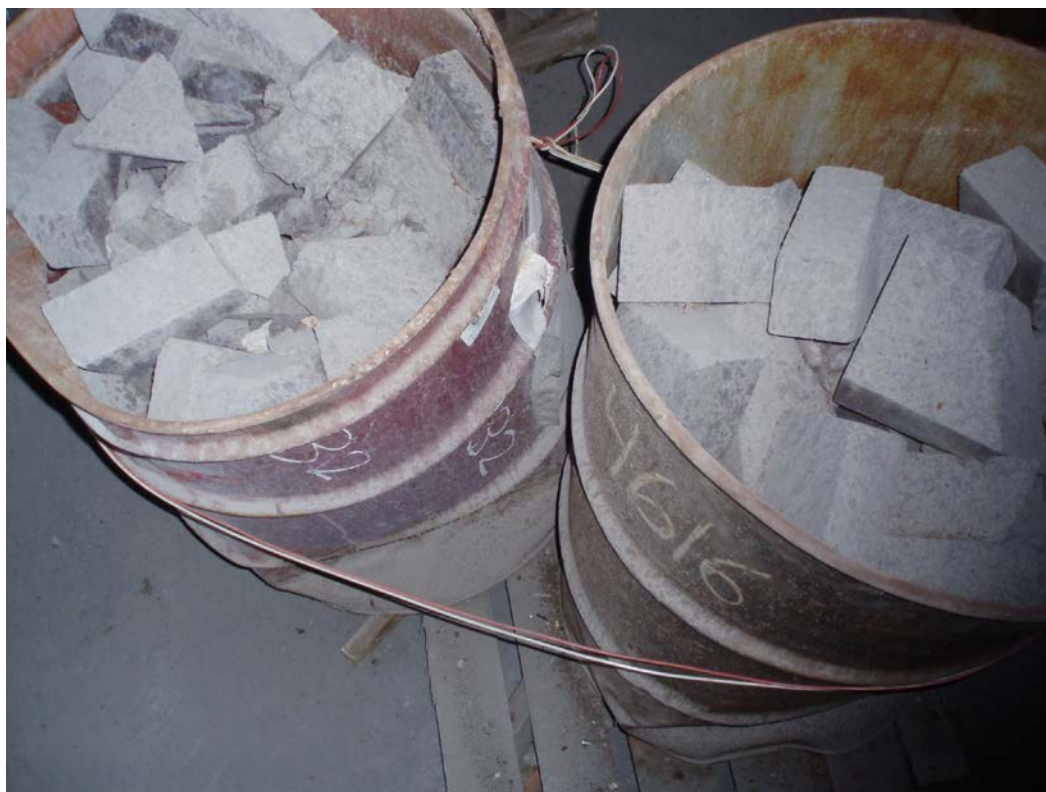
Date: 30 September 2010
Time: 11:32 am
Direction: SW
Photo by: M. Cozadd
Exposure #: 026
Comments: Close-up of refractory brick in drums inside Tank House.
